NEIFERT CREEK DAM
SCHUYLKILL COUNTY, PENNSYLVANIA
NATIONAL I.D. NO. PA 00654

PHASE I INSPECTION REPORT
NATIONAL DAM INSPECTION PROGRAM

WOODWARD-CLYDE CONSULTANTS
5120 Butler Pike
Plymouth Meeting, Pennsylvania 19462

June 1978

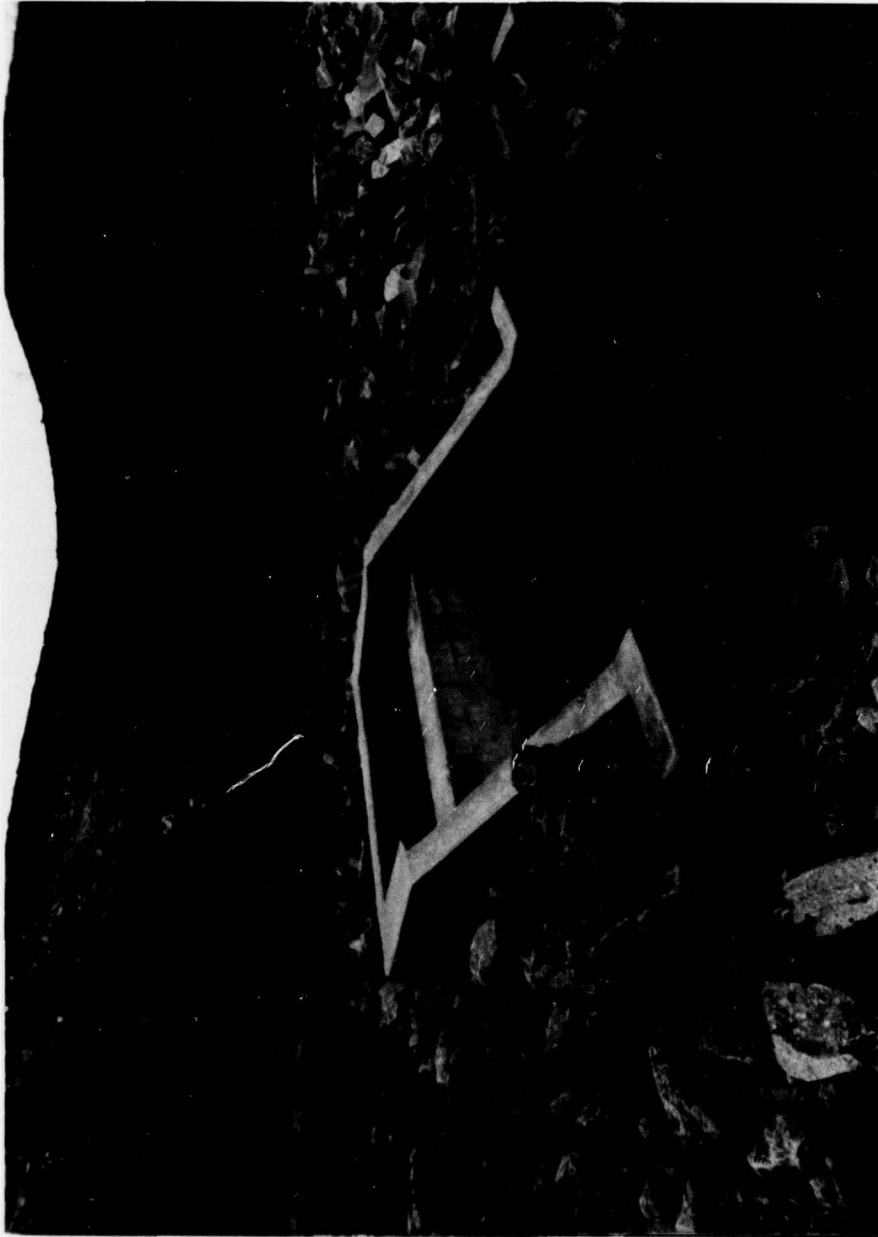
PHOTO NO. 2

VIEW OF OUTFALL STRUCTURE. BAFFLE WALL IS SHOWN ON
PHOTO IN FRONT OF OUTFALL PIPE.
